SPRING RIVER PARK AND ZOO

EXISTING CONDITIONS & DESIGN RECOMMENDATIONS

FINAL REPORT - JANUARY 2018

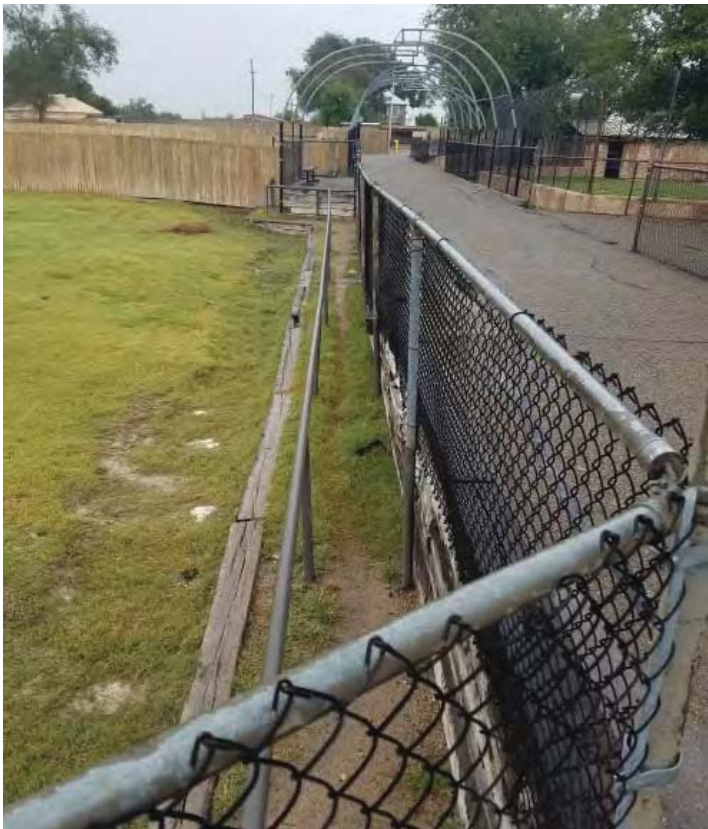
Exhibit restraint systems are inadequate and unattractive.

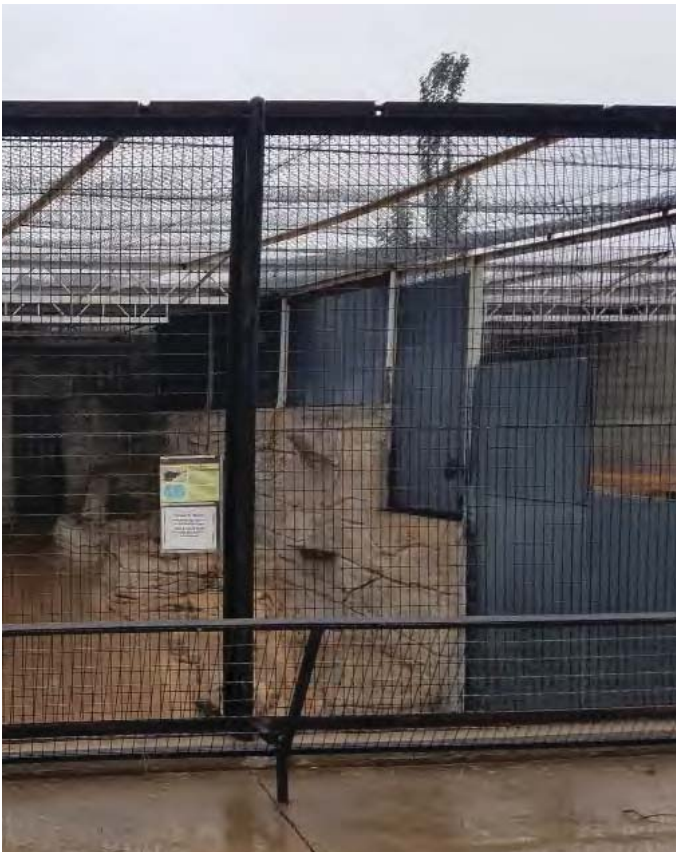
Bear exhibit is too small, but exhibit may be able to be enlarged by removing dividers or extending exterior walls. A structural analysis should be performed prior to any modifications.

- Perform a structural analysis on the bear and mountain lion enclosure to determine if walls can be removed to combine and/or enlarge the exhibit. There is an open turf area immediately west of the enclosure that could be incorporated into the exhibit adding much needed landscape and plantings. Reconstruct the nighthouses to modern industry standards.

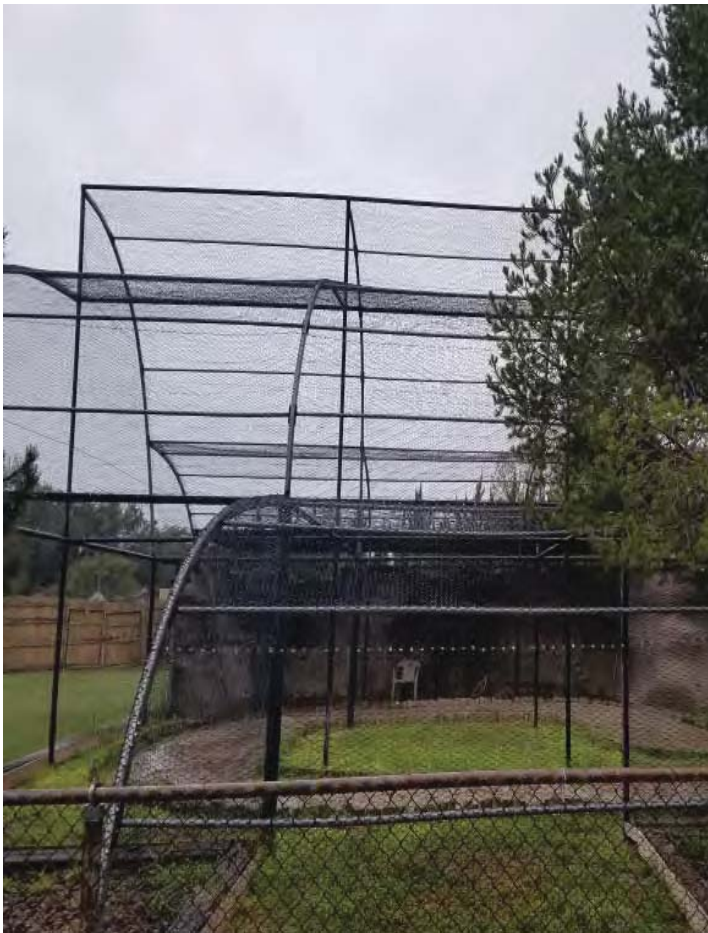
Aviary is empty while birds are kept in small cages.

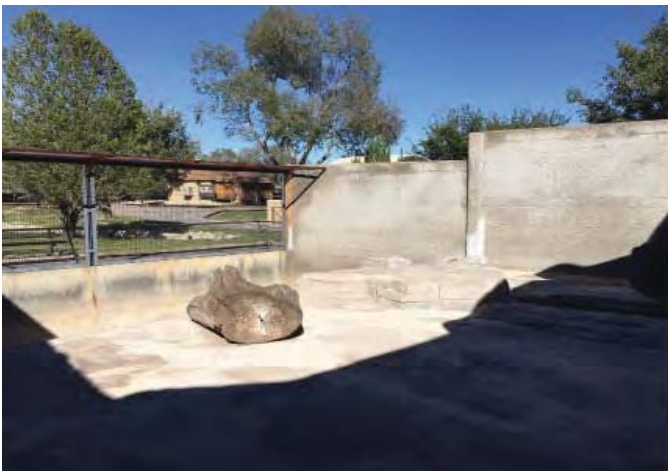
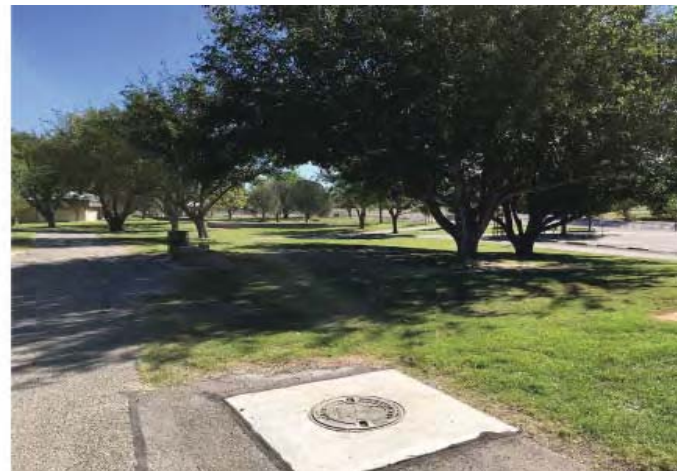
The existing bear enclosure may be able to be enlarged to give it new life. If structurally feasible, the east wall could be removed and the exhibit enlarged to encompass the open area just east of the exhibit. This would provide an adequate size for the bears and give them much needed soft landscaping.
